Archaeological Survey of Center Chapel, Franklin County, Kansas

Paul Thomas

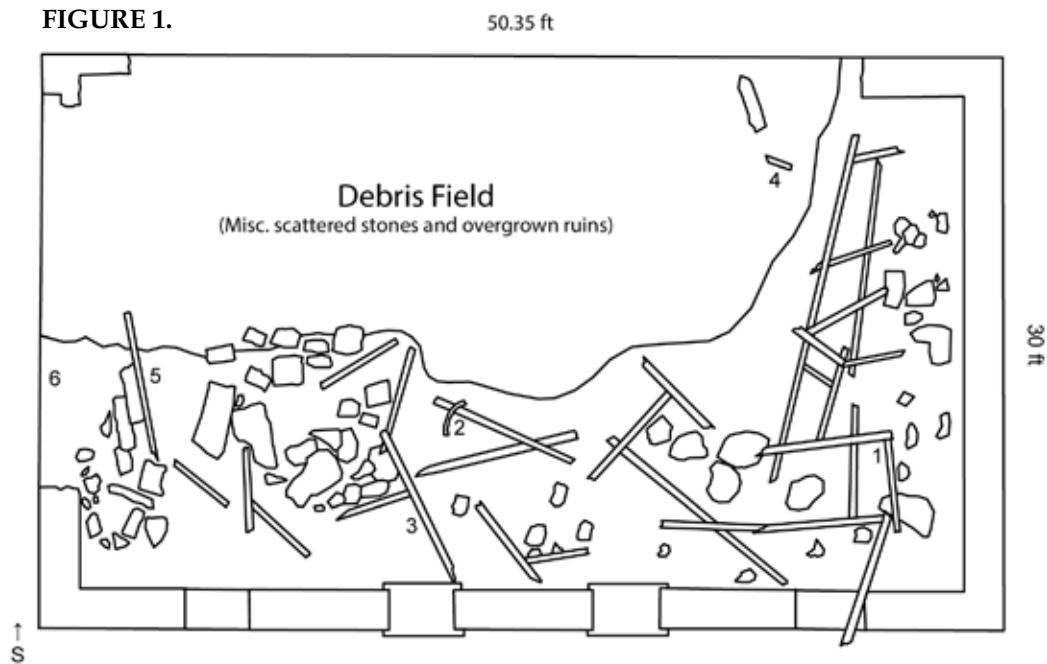
FIGURE 1.

corner—emerge from this mound. The northern part of the interior is scattered with fallen stones and wooden beams, although the beams are less densely layered than the eastern portion. Although most of the artifacts—especially the wooden ones—have been weathered, certain key finds were recorded inside the ruin. For instance, many of the wooden shards were identified as parts of the various windows' frames. Just south of the second window are the telltale remnants of both a jamb and a window's curved head. South of the first window, a lever from one of the windows' pulley systems was discovered. Directly north of the second window is the remnant of a decayed jamb. Curiously, it appears that all of the confirmed wooden remains belonged to the north wall's windows; no wooden remnants from the south wall's windows were discovered or documented (Fig. 1).

The site map of Center Chapel. South is oriented towards the top of the image. This map notes several artifacts including a lever from a window (1), an arching jamb (2), window beams with sockets for where the latches had been (3, 5), charred wood (4), and the original door cavity (6).

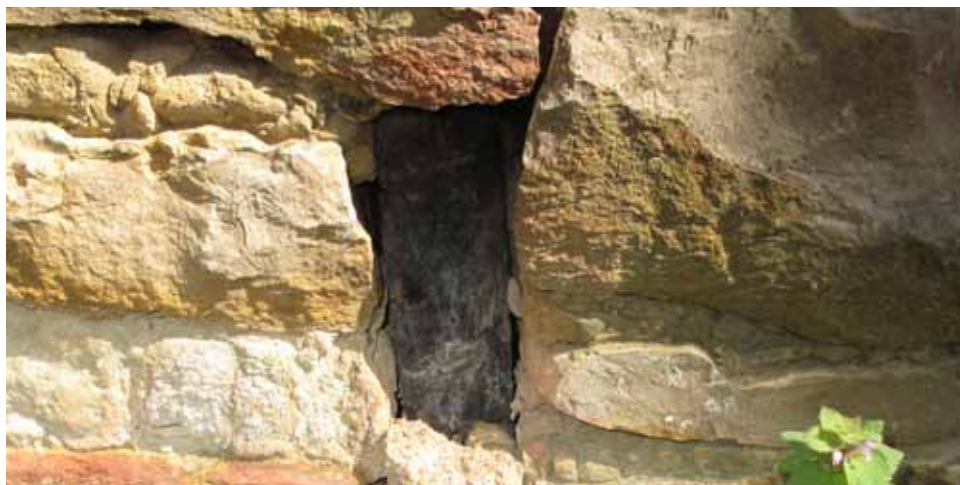
FIGURE 3.

Inside the ruin, key artifacts helped establish the various periods of use. The chapel, according to various sources, was constructed in the 1900s. This would be the first period of use. While documenting the site, it was noted that embedded wooden beams in the lower part of the chapel's interior walls were charred and blackened, evidence of a fire. What is more interesting, however, is that many of these beams were covered by plaster that had just recently begun to crack and flake away, revealing the carbonized wood beneath (Fig. 3). This is evidence that after a fire had burned much of the original wood, someone attempted to rebuild or at least repair parts of the chapel. This is the second period of use, which I referred to as the "post-fire" period. Finally, "out-of-place artifacts" found inside the ruin—such as modern bottles, cans, gutter railing, and contemporary wood beams—as well as the currently ruined state of the structure, seems to suggest

Carbonized wood, covered in plaster; this is evidence that the structure experienced a fire and then was repaired.

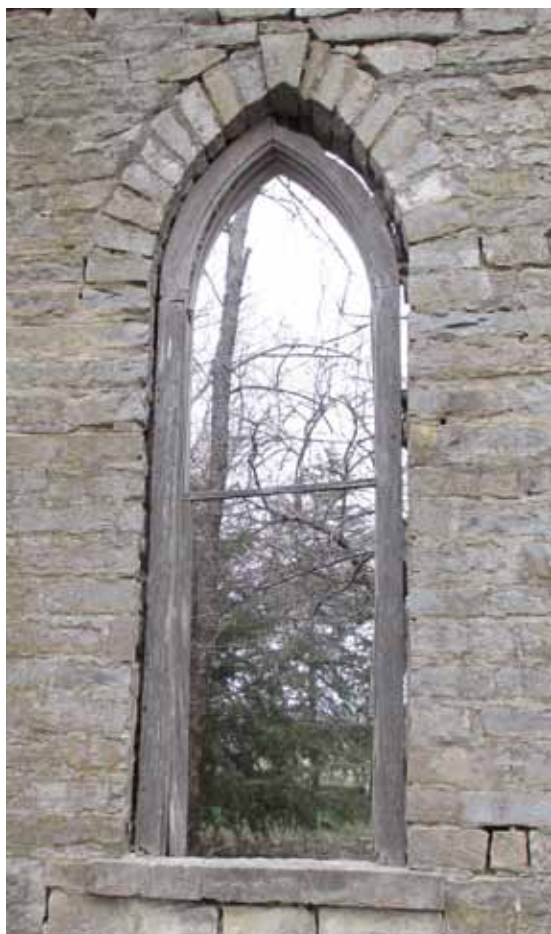
FIGURE 4.

Of note, the structure's third window still had the skeleton of the original window frame intact (Fig. 4). Unlike the other windows, whose frames had been scattered onto the ground and deteriorated, this window frame was in remarkable condition. Due to the settling of the structure, the frame was off-center and leaning heavily towards the eastern side of the stone cavity. However, both a single horizontal grille as well as the metal latches are still connected to the frame (Fig. 5). In addition, the internal weight and pulley system that were originally used to open and close the window are still preserved within the wood, although they have long since stopped functioning.

The third window, complete with frame.

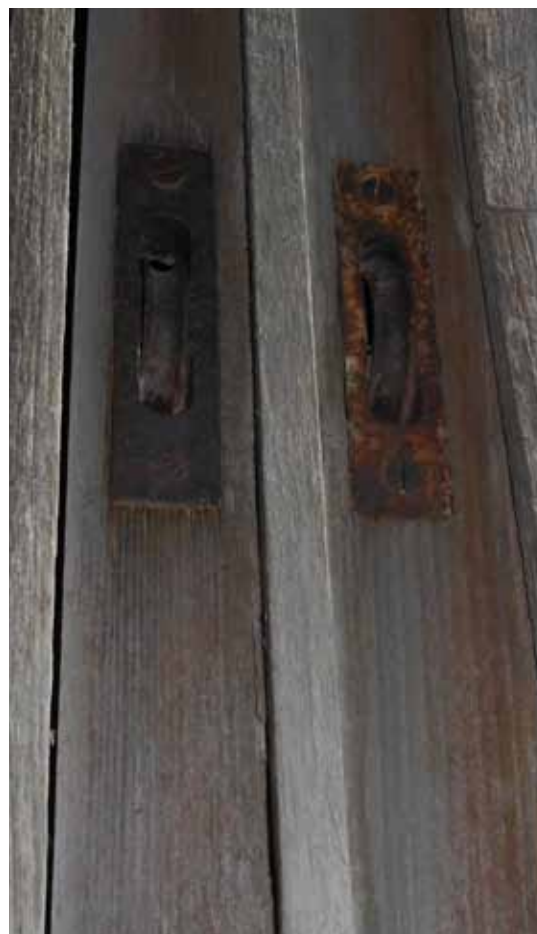
FIGURE 5.

The original metal latches to the third window's frame.
